# **LEARNING FROM ACCIDENTS**

**Captain Henk Hensen FNI**

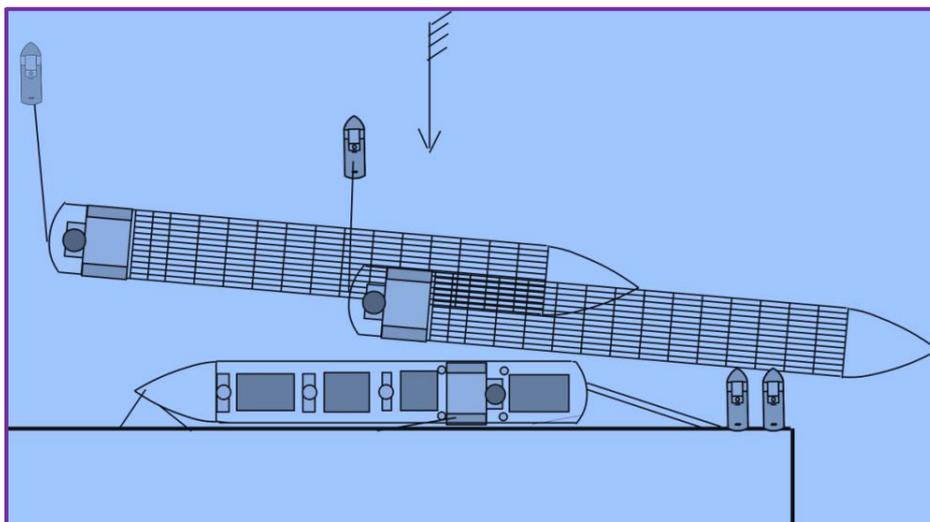
Figure 1. Accident with CMA CGM DeBussy

As an example, an accident to the container ship *CMA CGM DeBussy* will be used. The accident happened in the port of Constanta in March 2010. As a result of strong winds the ship drifted against the Turkish freighter *Haci Fatima Sari* and one of the assisting tugs was crushed between the container ship and the berth.

It is assumed the pilot *CMA CGM DeBussy* did not do that. He took the risk, or perhaps he had no idea there was any risk involved. The result was that the ship collided with a berthed ship and one of the tugs got crushed between ship and berth. Luckily, there were no casualties.

If the pilot had calculated the total required bollard pull, he could have seen that the three tugs available did not have sufficient bollard pull to keep the ship under control. The container ship probably had a working bow thruster, but as soon as a ship gathers headway the effect of the bow thruster decreases fast. This should have been taken into account. Because the pilot did not assess the required bollard pull, ships and tugs were put in danger.

*If the forward tugs had been pulling instead of pushing, the accident would not have had such serious consequences. The tugs could keep pulling up to the last moment, no tug would have been damaged and the damage to the ship alongside would have been less. In such critical cases it is better that the tugs are pulling as the stern tug did. In several other cases tugs have been crushed between ship and berth, and all these accidents could have been avoided.*

- Pilots should be trained to calculate the required bollard in case of strong winds. Some ports already do this, but many do not. All simulator training courses train pilots in how to handle a ship safely, but at least the simple calculation method outlined above should be included in the training.
- It is strongly recommended that in ports where pilots have to handle large container ships, gas carriers and car carriers, they are equipped with a simple tool that can calculate the required bollard pull.
- In case of emergency, tug masters should be trained to take the initiative to prevent the tug from becoming crushed (see note below).

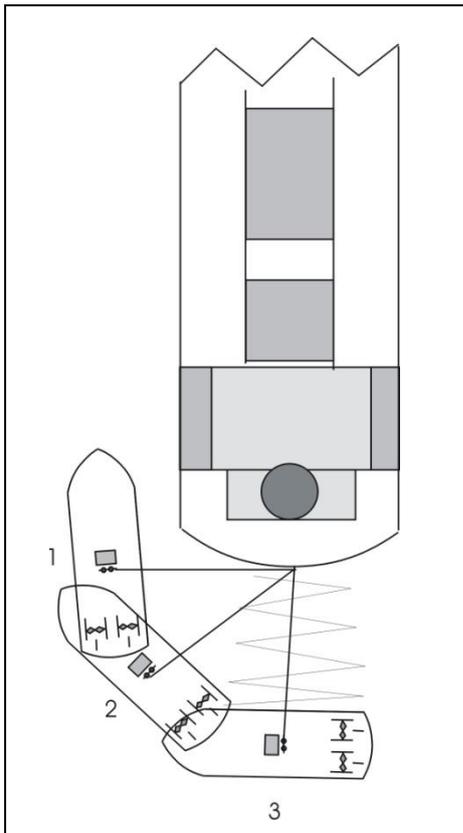
Figure 4a

Three other accidents. Lack of knowledge of tug capabilities has caused serious accidents, sometimes with fatal consequences.

An example: A pilot brought a bulk carrier into port. He asked for one ASD-tug as stern tug, but was told he would get the brand new conventional tug. Not aware of the limitations of the conventional tug, he instructed it to go from position 1 to a position astern of the vessel to assist in braking the ship's speed. The speed of the vessel at that time was at least about 5 knots and the engine was still on Dead Slow Ahead. The result was that the tug started to capsize in position 2 and was pulled by the ship, while capsized in position 3, for several minutes. The pilot was not aware this was happening. When approaching the berth, the ship's engine was stopped, so the force on the towline decreased and the tug came upright again. There were no fatalities.

It must be said that the tug master in this case, although very experienced, had no experience of the particular manoeuvre he wanted to carry out. Such manoeuvres should only be carried out at speeds below 3 knots and with the ship's propeller stopped! Accidents such as this one have resulted several times in serious consequences for the tug crew. The quick release system should have been activated, but does not always work in such circumstances. Sometimes the tug and crew are only saved by a breaking towline.

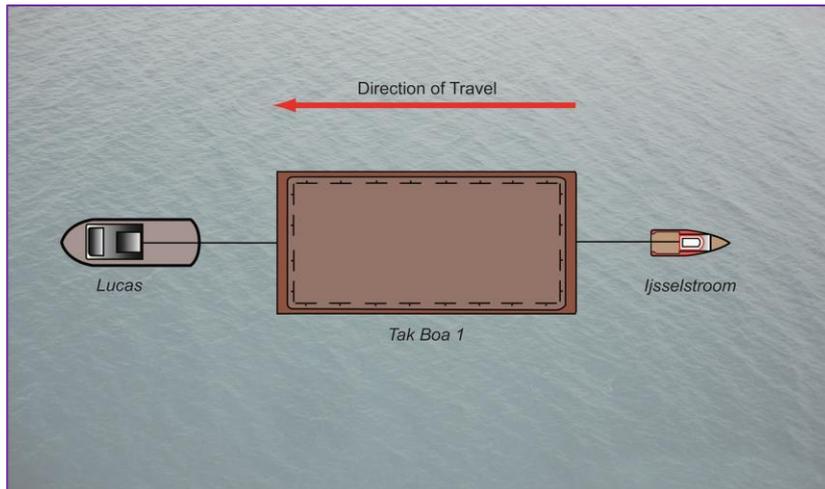
Figure 4b

A comparable accident took place recently with the twin-screw tug *IJsselstroom* in the Port of Peterhead on 14 June 2009 (MAIB report of 8 April 2010; ref. 2). Please, see figure 4b. The tug was a steering tug, with engines turning ahead to keep the tug in line with the tow. The risk with such a manoeuvre is that if with increasing speed (say up to 3 – 4 knots) the tug veers away, it will become impossible to bring it back in line with the tow. The towline under high tension will then come near right angles to the tug, which will result in capsizing. This is what happened.

The tug had no gob rope system, which COULD have prevented capsizing, IF speed through the water would have been less than about 3 knots, but bearing in mind the small heeling angle at which tug's deck edge submerges, this was by no means guaranteed. The rather old system of a gob rope winch, which can pull the towline down and shift the towing point to the after end of the tug, would have prevented the tug veering off and consequently capsizing. The tug was not equipped with such a system, which is compulsory on, for instance, German conventional tugs.

A radial system could also have prevented this accident, but the tug did not have such a system. The new Dynamic Oval Towing System (DOTS) which is fitted on the small tug *Ugie Runner*, or the Carousel System, could have prevented capsizing as well. These systems are

The major factor in these accidents is a failure to appreciate the limitations of the tug, by both the tug master and the pilot. And such accidents still happen much too often!

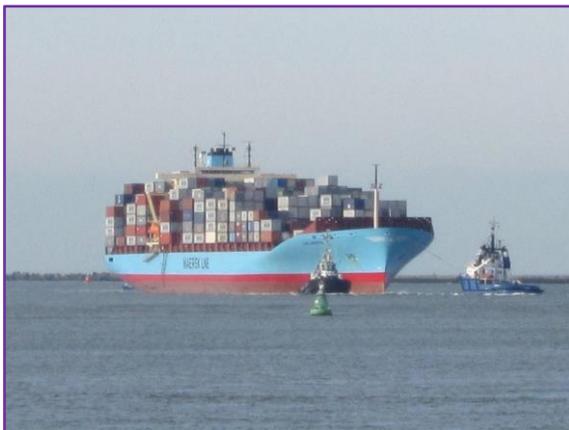
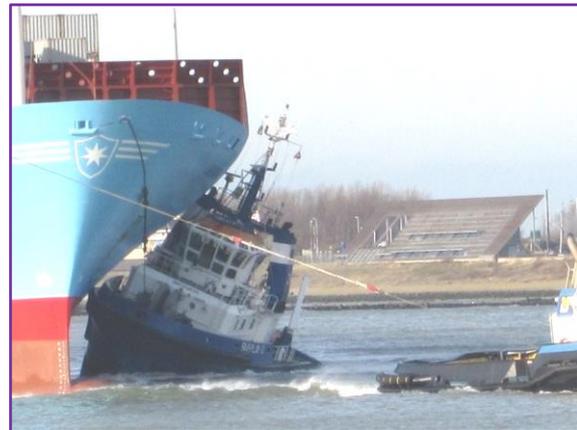
Figure 5 and 6 show another kind of serious accident. Such an accident do happen more than once with ASD-tugs operating bow-to-bow and are caused by a too high ship's speed and/or insufficient experience of the tug master with the specific ASD-tug. If ship's speed is the cause, then the pilot plays a role in it as well.

Operating bow-to-bow with an ASD-tug is a rather risky operation and needs a lot of experience and a thorough knowledge of the tug's capabilities and limitations particularly with respect to speed [ref. 3]. The tug shown swung around and came under the bow of the attended ship.

The accidents shown also demonstrate the importance of proper safety measures on board tugs. During tug operations doors, deck openings, etc. should be closed to prevent flooding of the tug with large angles of heel.

- The importance of experience with a specific tug type and knowledge of the capabilities and limitations of the assisting tugs, which applies to tug masters as well as to pilots.
- Most situations can be taught on a simulator, although in the case of bow-to-bow operations the tug model should carefully reproduce the capabilities of the ASD-tug when operating bow-to-bow. It should be recognized that there is a large difference between various ASD-tug designs.
- Careless thoughtless attitudes can be modified after a simulator training course.
- The importance of proper safety measures.

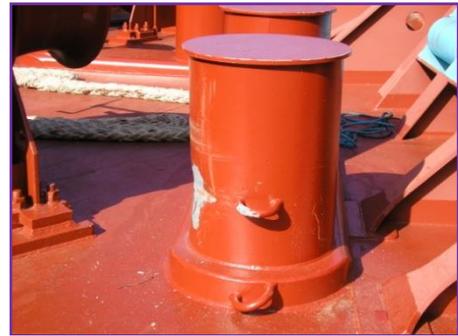
*Figuur 8*

*Courtesy: KOTUG, Rotterdam  
Top eye on bollard will damage the towline*
